**AREA B - EAST/WEST STREETS
EXISTING LIGHT LEVELS VERSUS
PROPOSED CRITERIA**

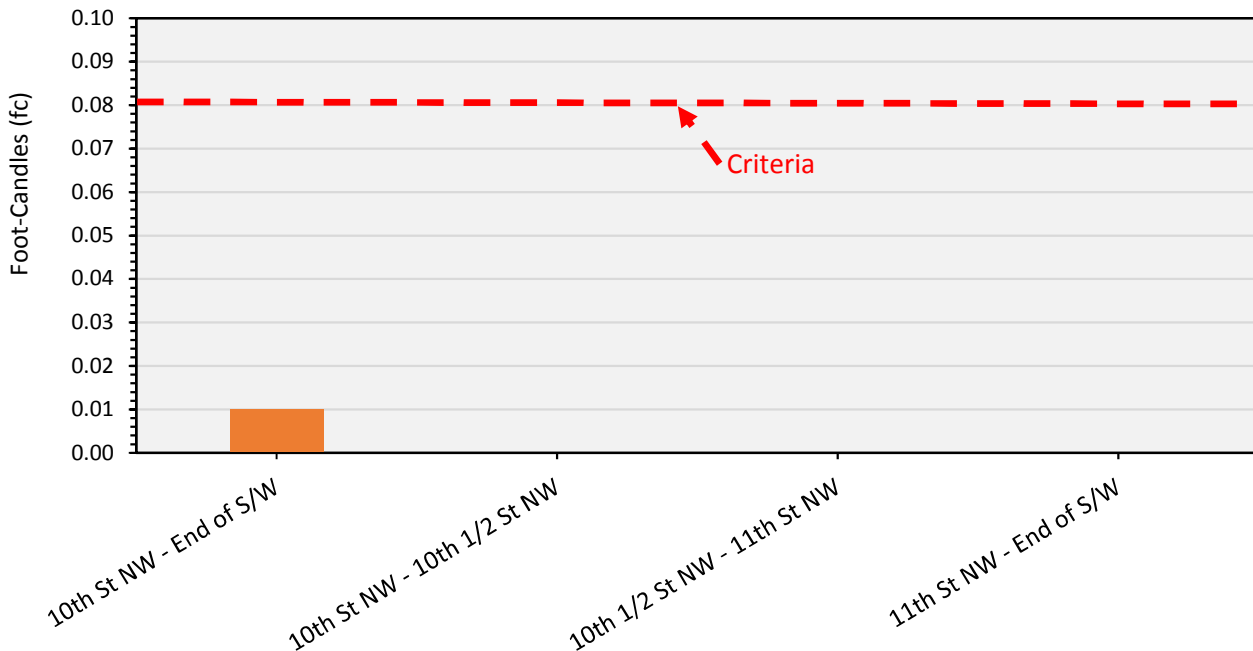
Page St - Westbound Min. Vertical Illuminance from Existing Lighting

1. Where no bar is shown, minimum vertical value of 0.00 fc was recorded.

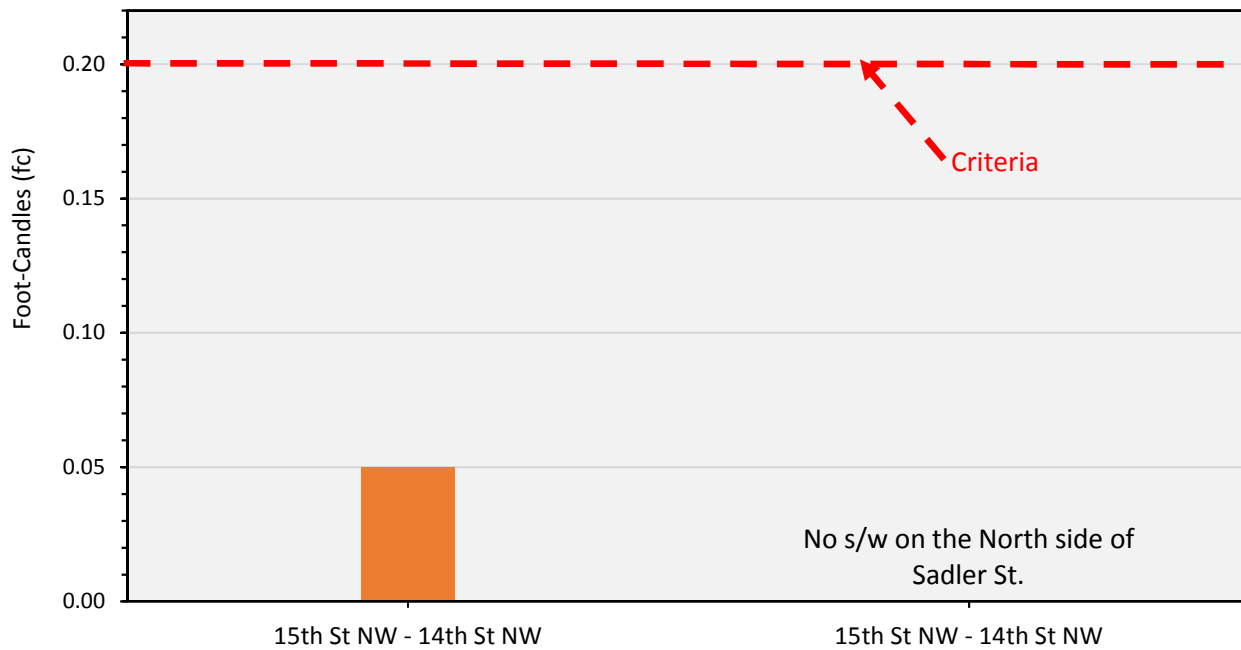
Sadler St - Eastbound Min. Vertical Illuminance from Existing Lighting

Sadler St

Sidewalk Width: 4ft
 Adjacent Land Use: Resedential
 Functional Classification: Local
 Pedestrian Activity: High

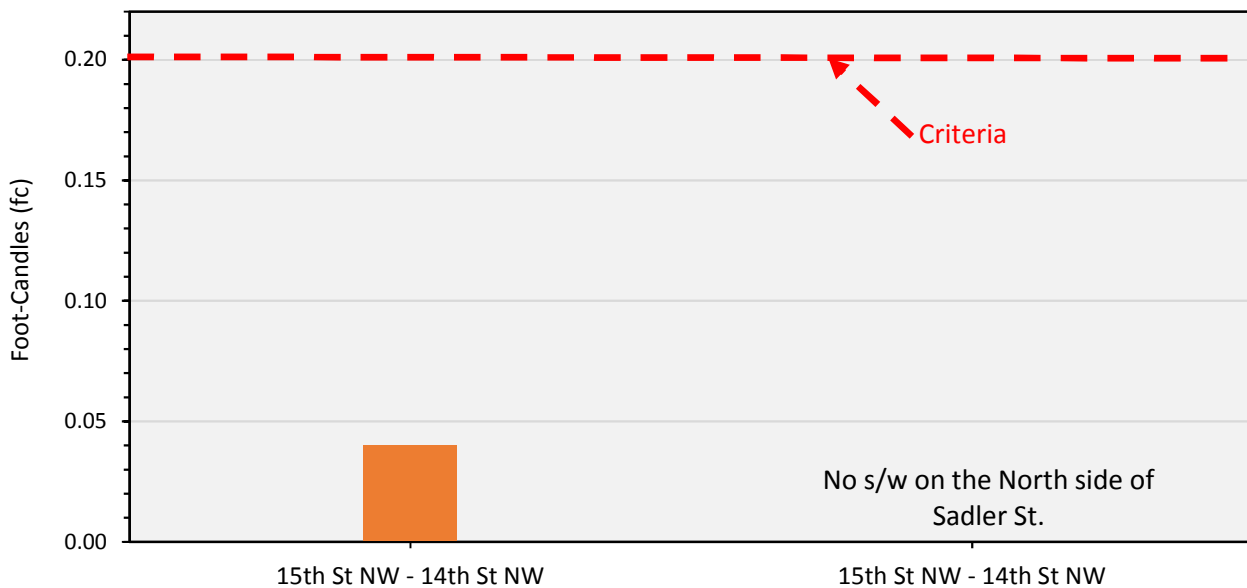
Sadler St - Westbound Min. Vertical Illuminance from Existing Lighting

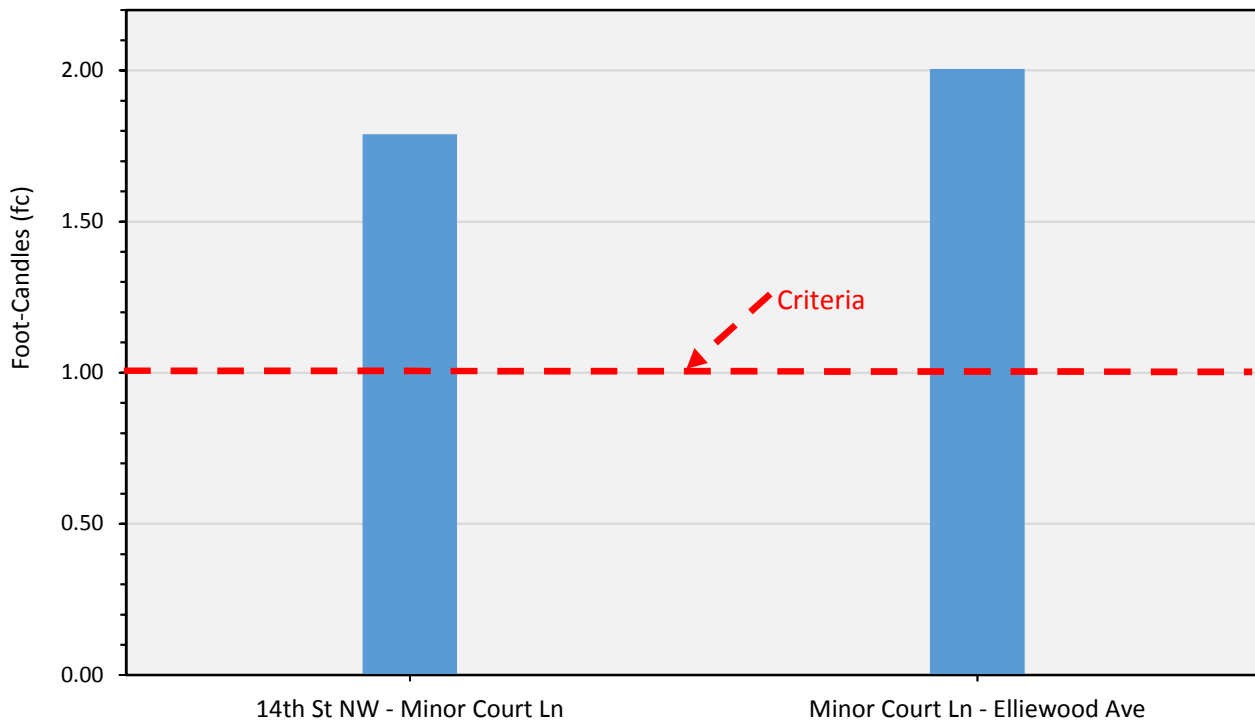
University Ave - Average Illuminance from Existing Lighting

University Ave

Sidewalk Width: 8ft

Adjacent Land Use: Commercial

Functional Classification: Other Principal Arterial

Pedestrian Activity: High

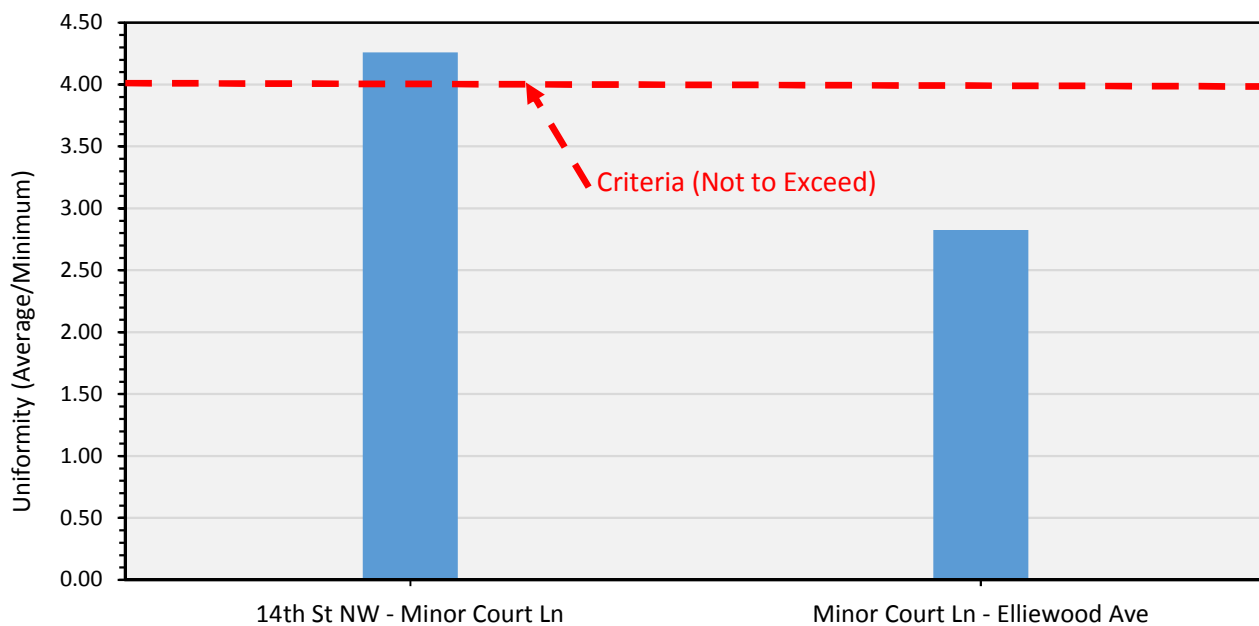
University Ave - Horizontal Uniformity from Existing Lighting

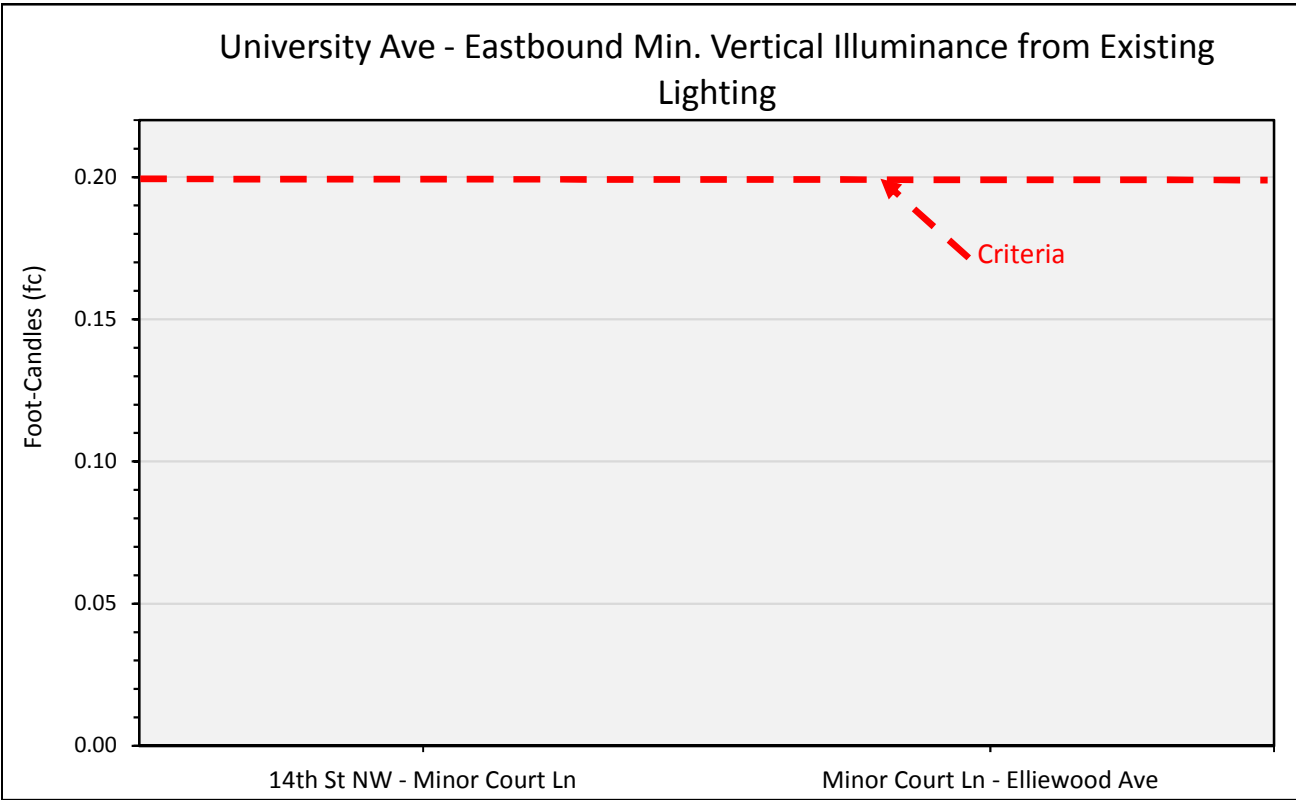
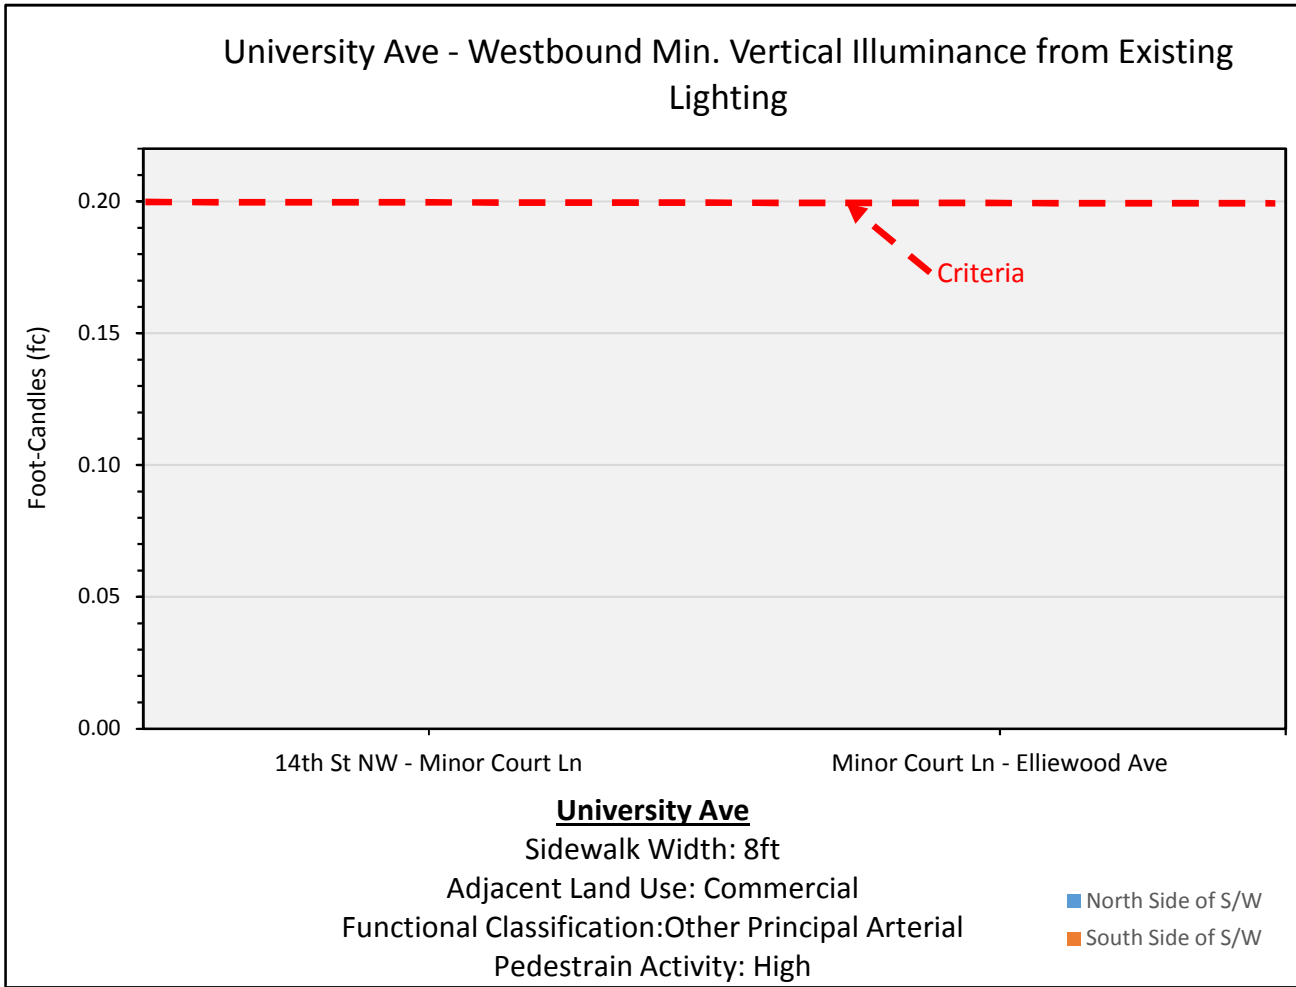
Note:
 1. Where no bar is shown, minimum vertical value of 0.00 fc was recorded.
